Bridge in Cala Galdana on Menorca

BRIDGE IN CALA GALDANA ON MENORCA

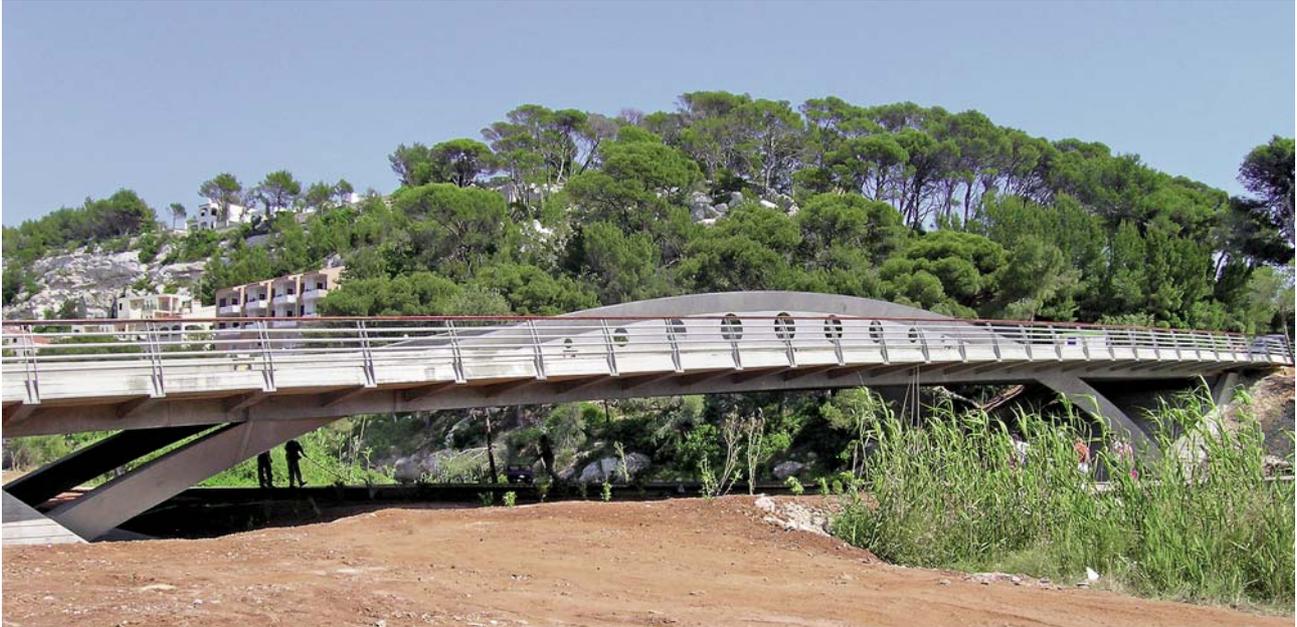
The inclined struts between the outer ends of the arches and the longitudinal beams take up the horizontal forces in the arches, thereby relieving pressure on the foundations.

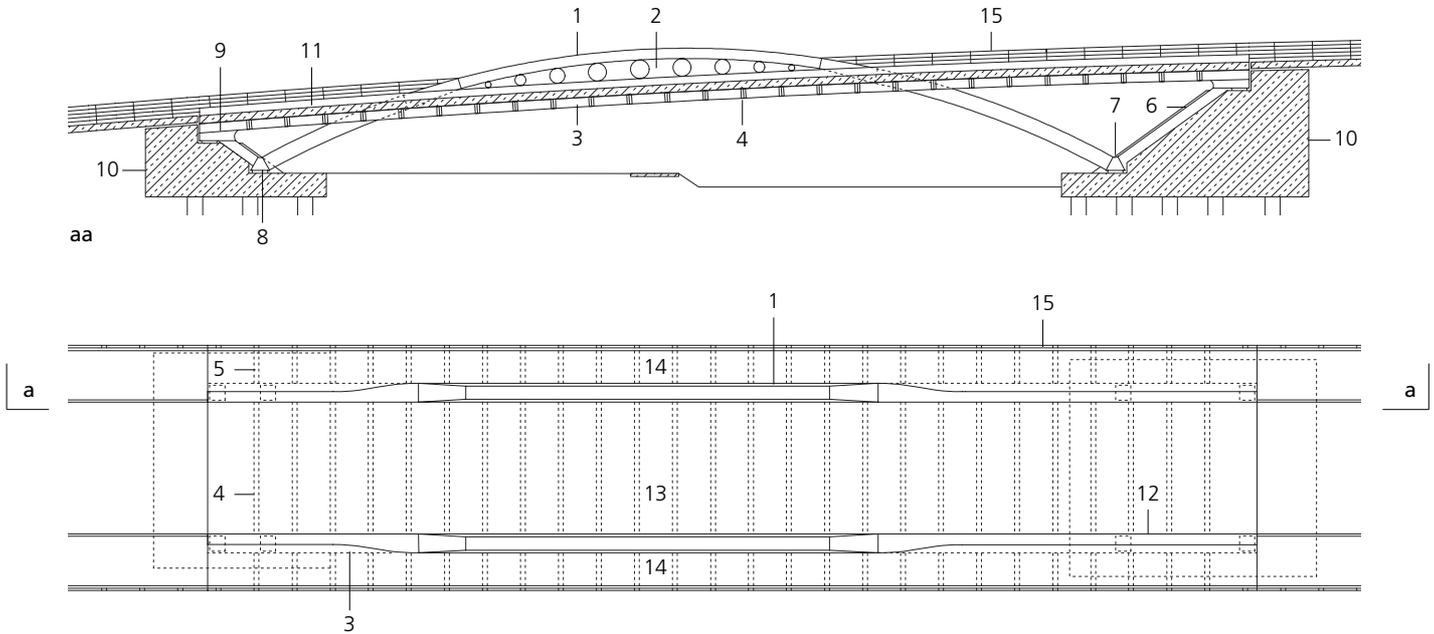
Longitudinal section · Plan scale 1:400

- 1 arch, welded hollow section with central web, 700-1000/700/20-25 mm
 - 2 15 mm web
 - 3 longitudinal beam, welded hollow section with central web, 1000/500/15-25 mm

- 4 transverse beam, welded hollow section 250/500-570/10-12 mm, connected to reinforced-concrete deck via Ø 20 mm studs
 - 5 cantilevered beam, welded hollow section, 250/300-50/8-10 mm

- 6 strut, welded hollow section, 1000/500/20-25 mm, with welded transverse and longitudinal reinforcement
 - 7 connection between arch and strut, welded hollow section of 25-40 mm plates, with welded transverse and longitudinal reinforcement

- 8 pot bearing, stainless steel
 - 9 elastomeric bearing layer, anchored
 - 10 reinforced-concrete foundations
 - 11 470 mm (centre line of bridge) reinforced-concrete deck

- 12 concrete wall
 - 13 road surface
60 mm asphalt on bitumen membrane
 - 14 walkway surface, simulated limestone pavers
 - 15 railings: 2x 1290/10 mm flat-steel posts, Ø 50 mm tubular steel horizontals, 150 mm wide wooden handrail

- All steel components are of stainless steel, grade 1.4462.

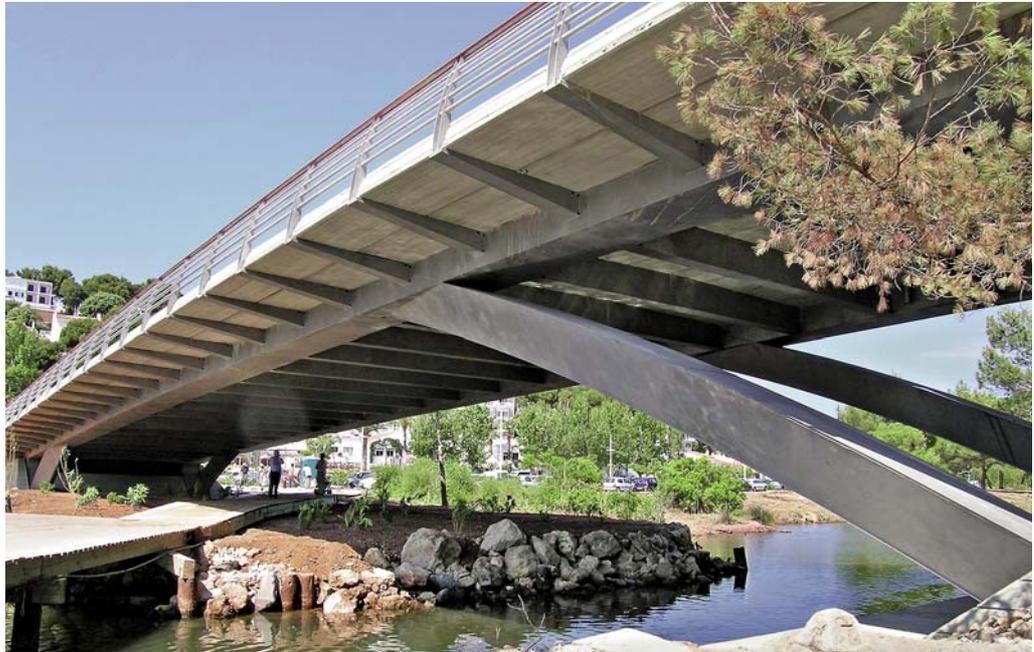
Curving slightly inwards, the railing posts are attached to the cantilevered transverse beams and connected to each other horizontally using stainless-steel tube. On top of the railing is a wooden handrail.
