### Drinking water systems in stainless steel

In a new extension to the accident and emergency clinic in Murnau in southern Germany, the highest standards of hygiene and safety were a priority in the design of the drinking water system. It was therefore decided to construct it largely in stainless steel. The system is divided into four sections, each capable of functioning independently, thus facilitating maintenance and repair work on the separate sections. Isolating valves and valve taps were fitted to the pipes, to enable individual cleaning and disinfection without interrupting the supply.

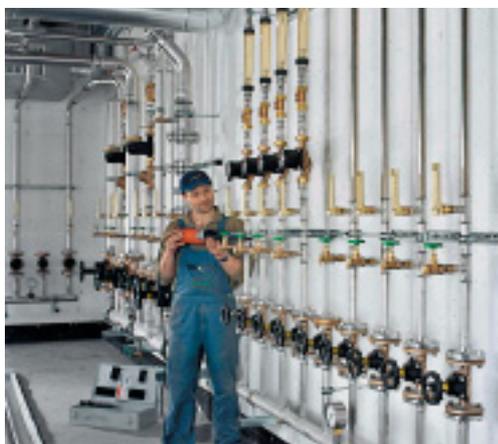
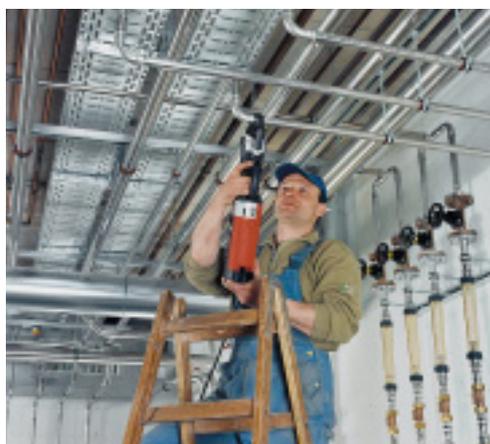
*A total of 12,900 running metres of stainless steel (DN 15-150, grade 1.4401) was used in the accident and emergency clinic in Murnau.*

At the accident and emergency clinic stainless steel was used not only for the pipework, but also for the drinking water storage system, comprising a water tank, a reaction tank and a plate heat exchanger for heating hot water. The combination of a storage charging system and a continuous-flow water heater caters for periods of peak demand.
